Manhole Inspection Summary

Manhole # S09YY1016MH

Location Address: **2601 Manhattan Ave**

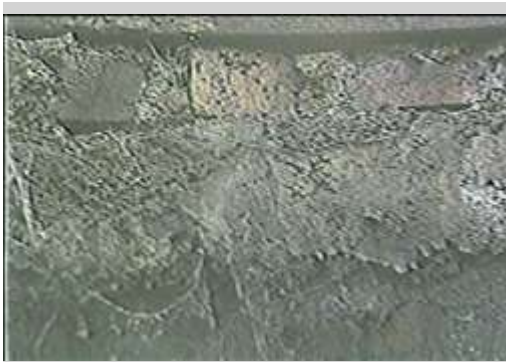
Defect

Condition: ☐ Sound ☐ Cracked ☐ Root Intrusion ☐ Loose Brick ☒ **Deteriorated**

Infiltration: ☐ None ☒ **Joint** ☐ Cracks ☒ **Mortar** ☐ Roots ☐ Wall

Adjustment infiltration

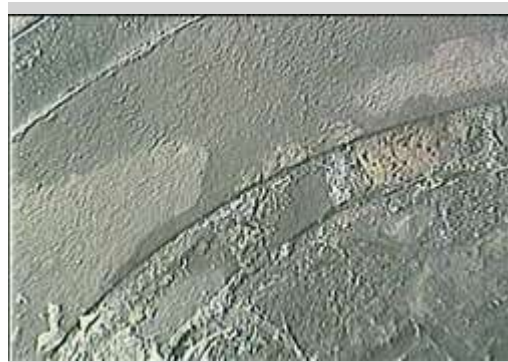
Defect

Frame leak, Adjustment infiltration

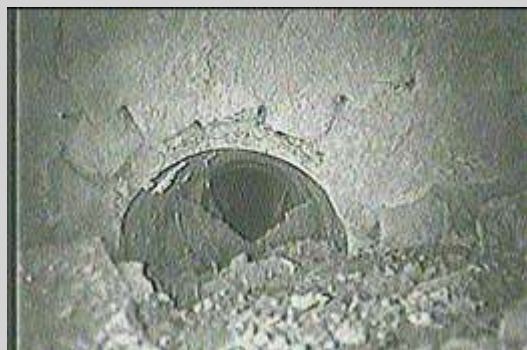
Pipe Out @ 12 O'Clock

8 in. Circular Gravity Sewer

Deposits: ☐ None ☐ Mud ☐ Sludge ☒ **Debris** ☐ Grease

Silt Depth: **2** (in.) Deposits Extent: **Medium**
